Removal and Service of Driver Air Bag and Location of Components

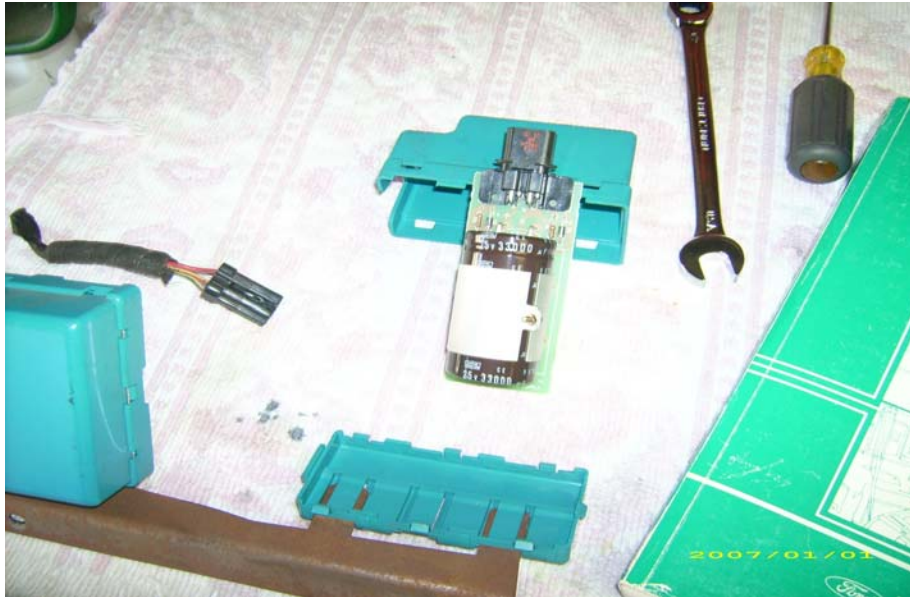
Disassembled back up power supply

The driver air bag restraint consists of four impact sensors, a control module, a backup power supply, and the air bag itself. Three of the sensors are located on the front of the radiator core support and one is located in the driver side interior kick panel. Any two sensors must detect impact. The system operates in a front impact only. The backup power supply contains a capacitor to provide detonation of the charge which deploys the airbag

should the automobile battery or wiring be damaged or shorted during a collision.

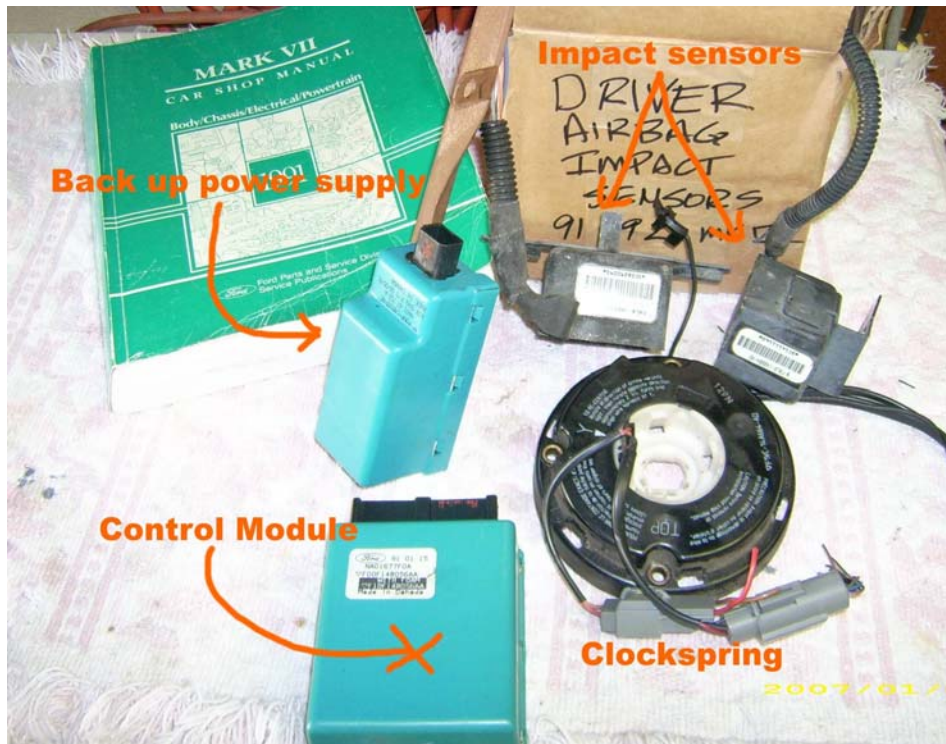
Components

A clock spring is used behind the steering wheel as opposed to brushes and rings as in the earlier models. The cruise control and horn also make electrical connection through this unit. It is a strand of multi conductor wire wrapped like a “clock spring” within a plastic housing. It winds and un-winds as the steering wheel is turned so continuous contact is maintained should impact damage the steering wheel to column interface.

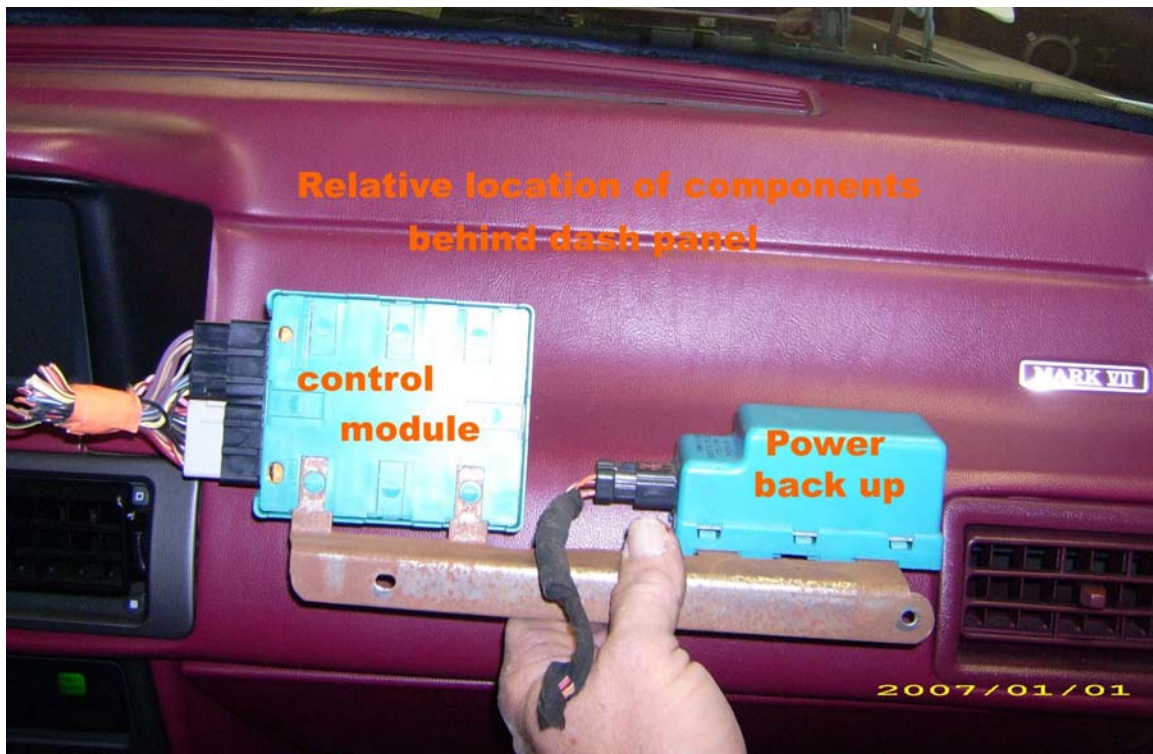
Component Location

As discussed above, the impact sensors are located on the core support and kick panel. The clock spring is located between the steering wheel and column and steering wheel removal is required to replace it. The Power back up and control module are located above the glove box door, attached to the interior of the dash panel. The glove box need not be removed to access these components.

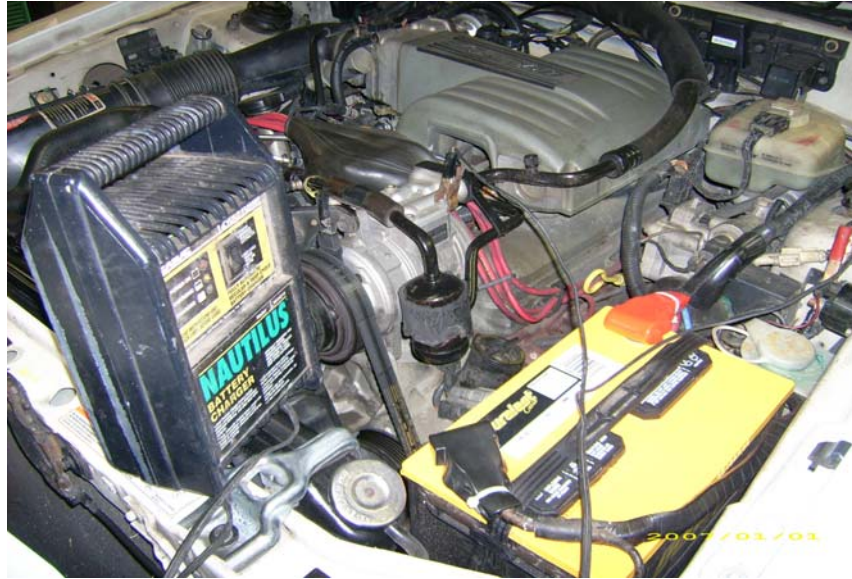
After the air bag itself has been safely removed, re-connect the back up power supply and connect the battery. I connected a battery charger to keep my battery up during this process.

To troubleshoot the clock spring, it must be checked for continuity. This is accomplished by inserting a jumper into the harness plug, which would plug into the “now removed” air bag unit.

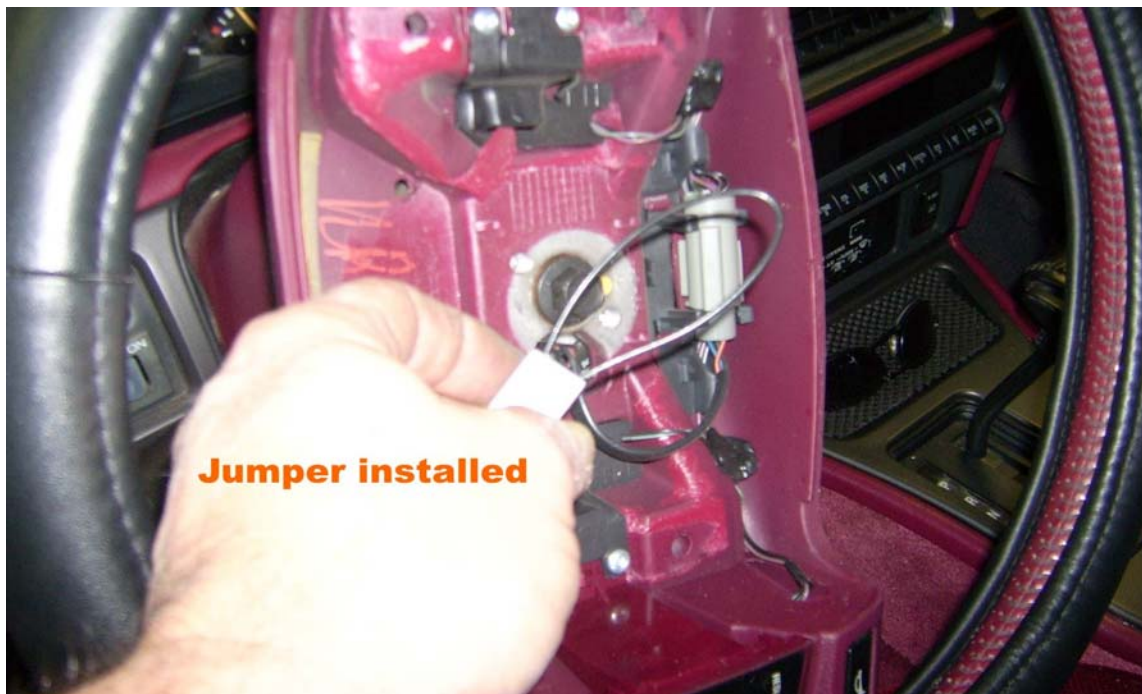
The ignition switch was turned on and the warning lamp was observed for codes. Mine still flashed out a five code.

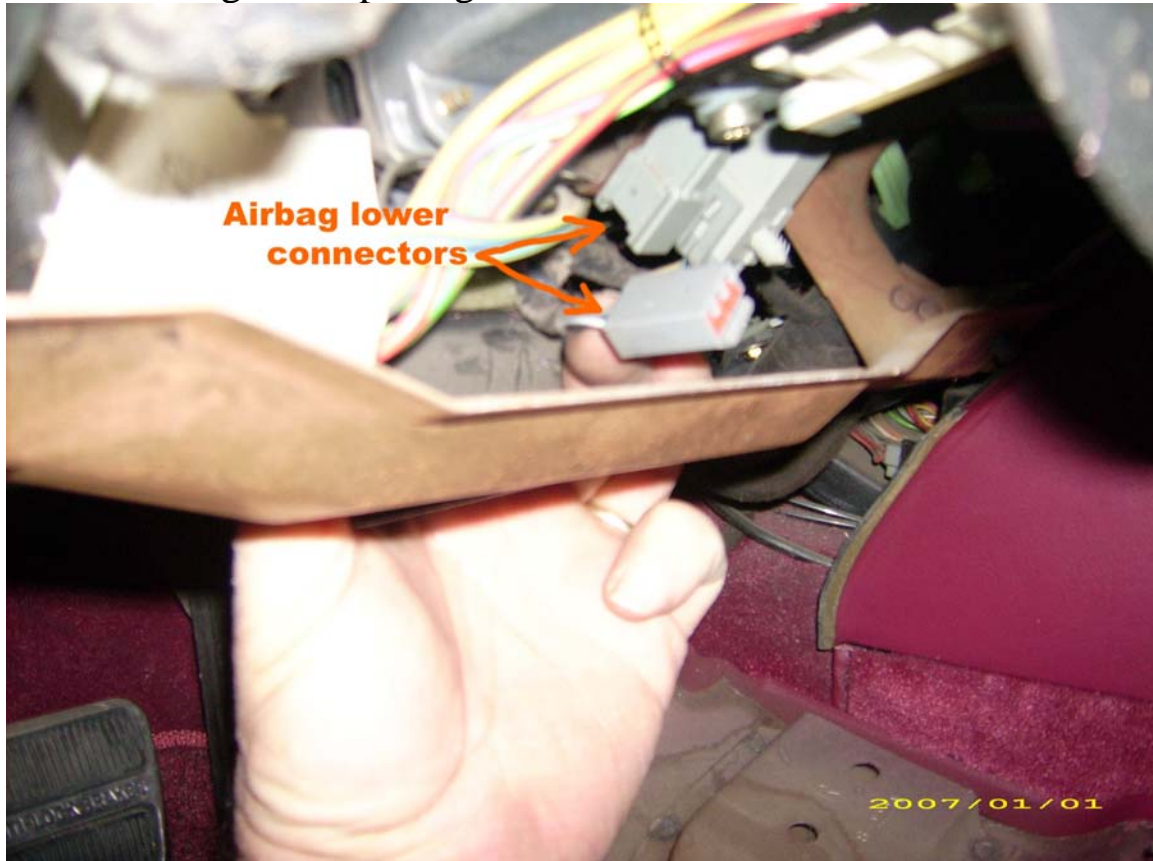
The next test was to check the connector at the base of the steering column where the pigtails from the column side of the clock spring connect to the vehicle harness. The panel cover beneath the steering column must be removed and two gray connectors are visible through the opening.

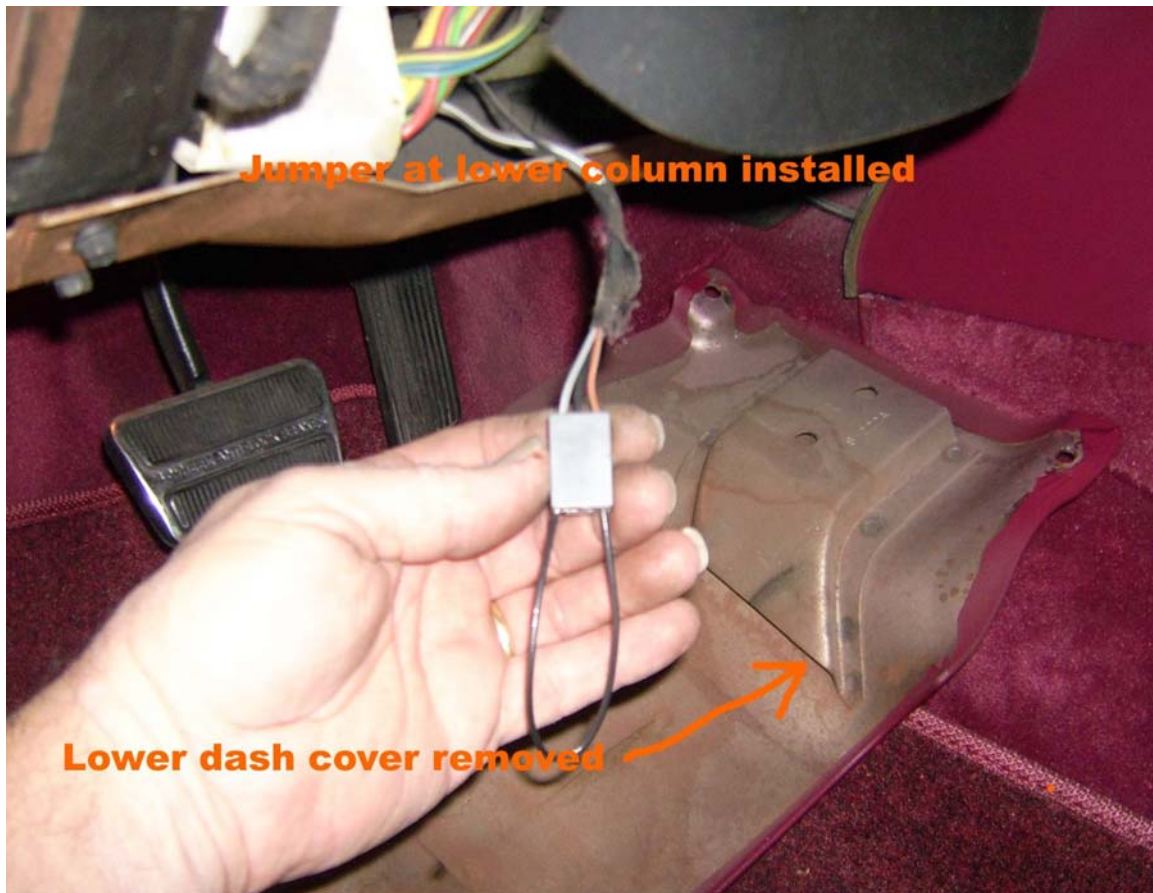
A jumper was installed at the vehicle harness connector and codes were re-checked by again turning on the ignition.

In my case, when the ignition was turned on again, the warning lamp again flashed a 5 code.

The jumper was removed and ignition was again turned on and a 10 code was observed, which meant, "Replace module"

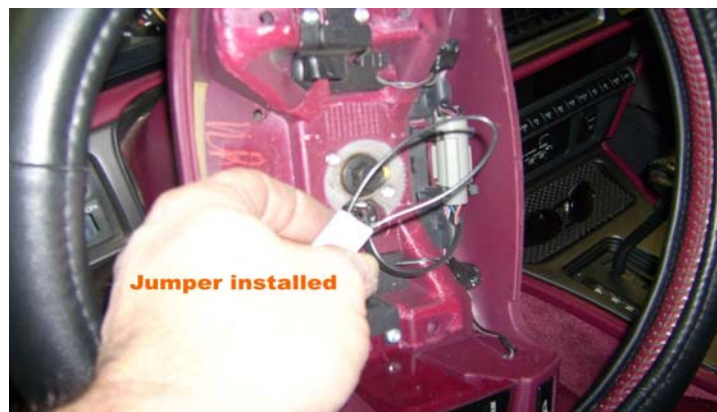
The warning light came on for two to three seconds and shut off.

After reinstallation of the replacement module, the backup power supply was re-connected, the harness connector at the lower steering column was re-connected, and the battery was re-connected. A jumper was installed at the plug behind the air bag unit at the steering wheel, and the ignition was again turned on.
